## SYSTEM FAILURE CASE STUDIES

OCTOBER 2011 VOLUME 5 ISSUE 9

# Tough Transitions

#### Three Technicians Die Before Space Shuttle Columbia's Inaugural Launch

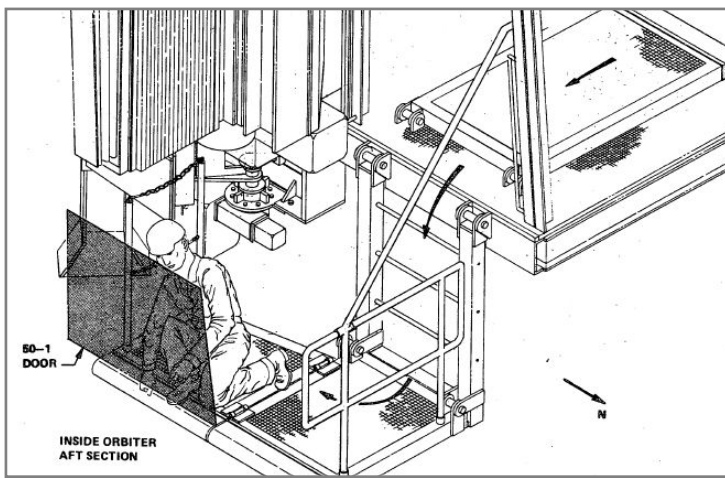
**Figure 2: The curtained 50-1 door granted access to the shuttle's aft crew compartment.**

Rockwell International (RI) technicians John Bjornstad, Forrest Cole, and William Wolford arrived at the shuttle access point on the 130-foot level of the rotating service structure (RSS) and checked in at the monitor station at 9:15 am. The orbiter aft compartment was located behind the curtained 50-1 door (Figure 2), and Bjornstad entered first. Cole followed, and Wolford entered third.

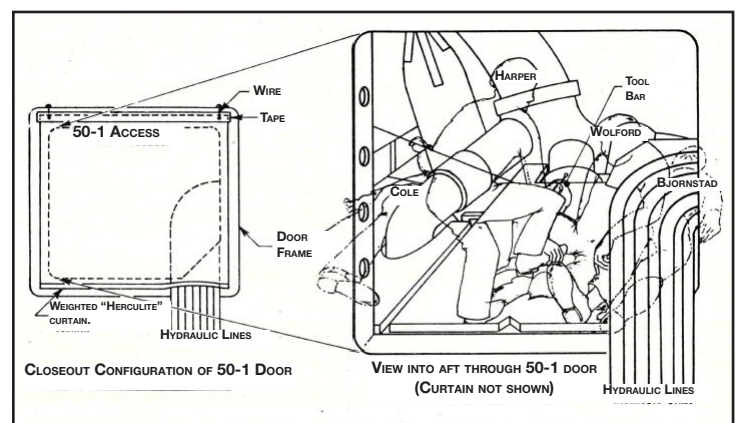
At 9:21 am, RI technician Jimmy Harper arrived at the 50-1 door to discover Wolford and Bjornstad unconscious inside the compartment (Figure 3). Harper entered to help the fallen men, but in doing so collapsed backward onto the service platform just outside the 50-1 door. RI technician Nick Mullon and RI quality inspector W. Corbitt arrived at the threshold as Harper fell. Spotting the unconscious technicians through the door, Mullon was able to drag Wolford out of the compartment while Corbitt called for help.

**Figure 3: View into aft compartment from the platform outside the 50-1 door depicting approximate locations of fallen technicians at around 9:21 am.**

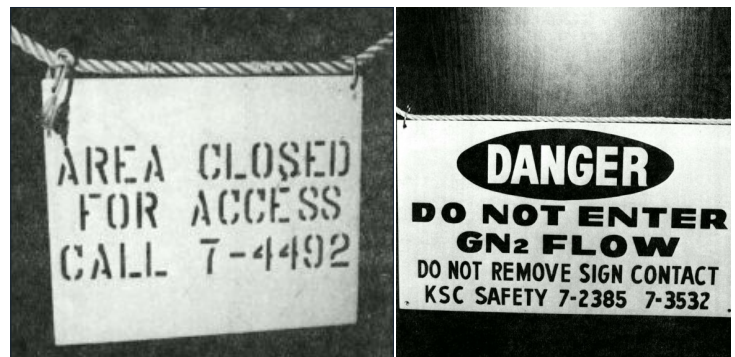
KSC Safety documents lacked requirements or effective procedures to control access to work areas exposed to an inert gas environment despite significant asphyxiation risk. A “hazard warning” sign, which would have secured the area, should have been posted outside the confined space. Instead, an “access control” sign, which can be removed from an area without concurrence from Safety personnel, was placed near the orbiter interior (Figure 4). The access control procedure should also have included atmosphere checks to verify a safe environment within the compartment prior to sign removal, just like the checks performed for hazardous gases elsewhere (booster and engine nozzles, and areas surrounding GN<sub>2</sub> plumbing).

**Figure 4:** Access control signs (left) can be removed without concurrence from Safety Personnel. After the accident, personnel were required to use the sign depicted at right for GN<sub>2</sub> purges.

After the pre-STS-1 tragedy, NASA implemented many changes to strengthen safety practices related to procedural deviations and access control. These included constraints on deviation traffic, requirements for atmosphere sniff checks, barrier placement and removal, use of warning lights, and placement of standby emergency officers. NASA provided GN<sub>2</sub>-specific warning signs for areas affected by GN<sub>2</sub> purges and installed an oxygen deficiency monitoring system in its Shuttle Processing facilities. Temporary air packs were staged in enclosed compartments within the spacecraft in addition to nearby access platforms. Mandatory training on the use of the air packs was implemented as a part of the area access training.
